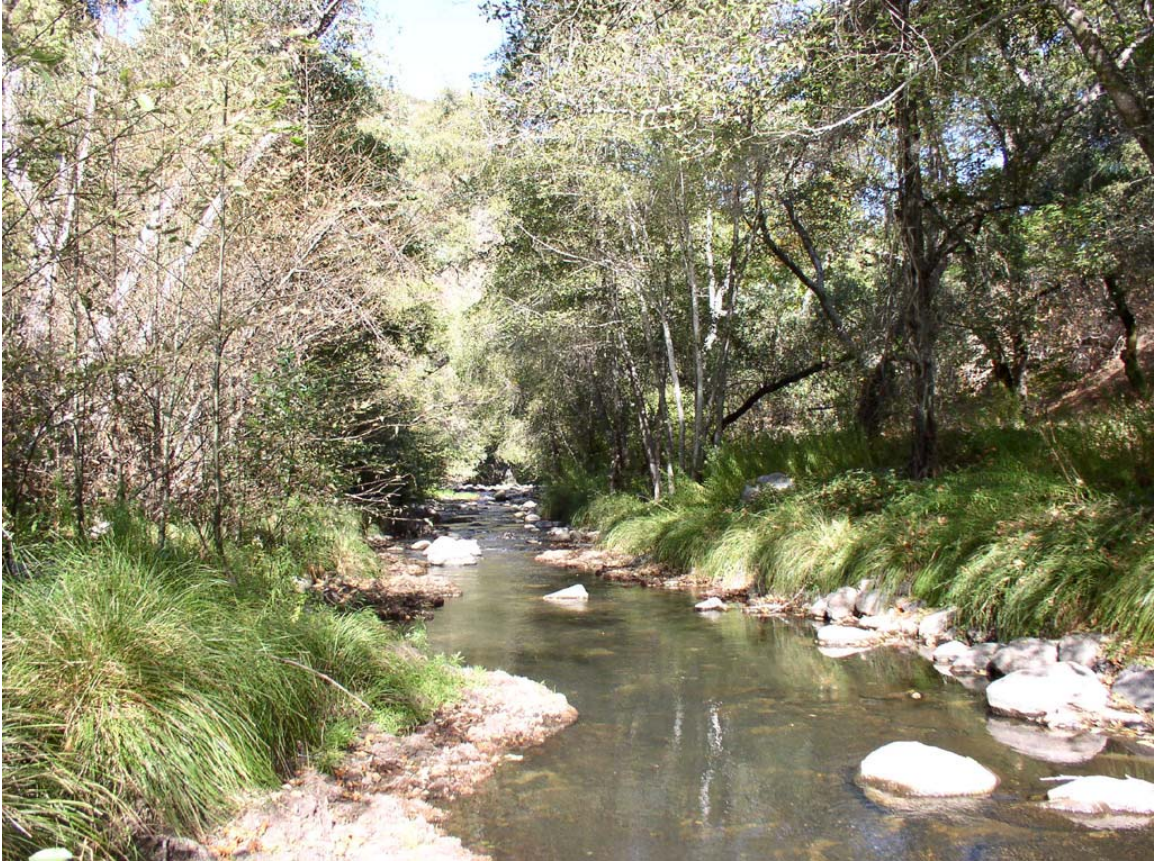
Stream reach is just below last house on the way to Pine Creek from Syndicate Camp in the Cachagua area. Vegetation consists of white alder, willows, and sycamores.
