Standard Checklist

Name of Riparian - Wetland Area: Carmel River Watershed - Pine Valley Area

Date: 4/8/04 Segment/Reach ID: 36-Carmel River just above Pine Falls

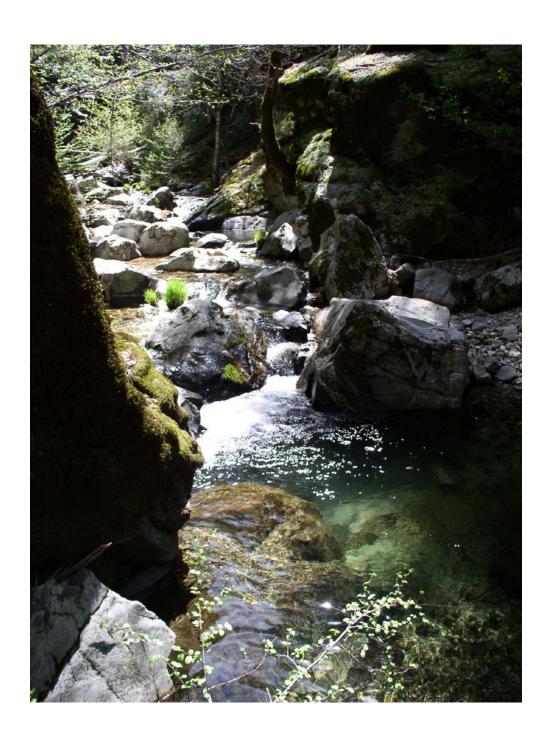
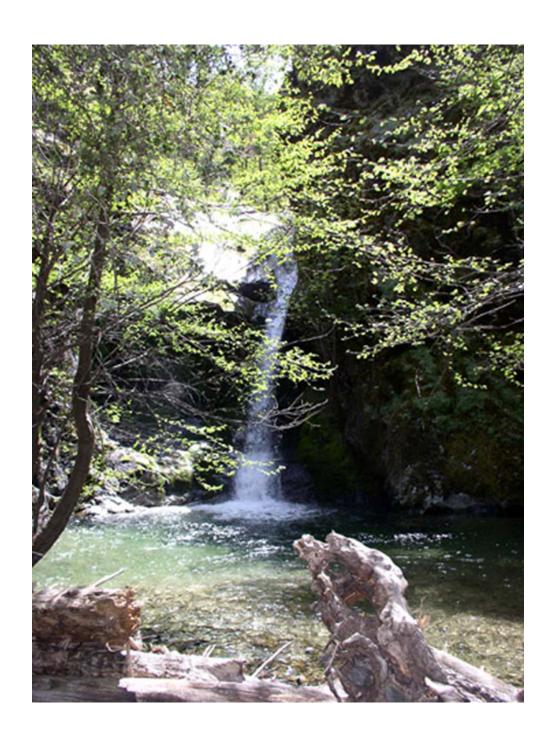
Large boulders exist to dissipate energy. Riparian species include white alder and Santa Barbara sedges.
Pine falls is considered a fish barrier and is approximately 25 to 35 feet high.
Summary Determination
Functional Rating:
Proper Functioning ConditionX Functional – At Risk
Functional – At Risk Nonfunctional
Unknown
Trend for Functional – At Risk:
Upward
Downward
Not Apparent
Are factors contributing to unacceptable conditions outside the control of the manager?
Yes
No <u>X</u>
If yes, what are those factors?
Flow regulations Mining activities Upstream channel conditions Channelization Road encroachment Oil field water discharge
Augmented flows Other (specify)
