Standard Checklist

Name of Riparian-Wetland Area: Potrero Creek

Date: June 17, 2004 Segment/Reach ID: Reach 4 PFC 101

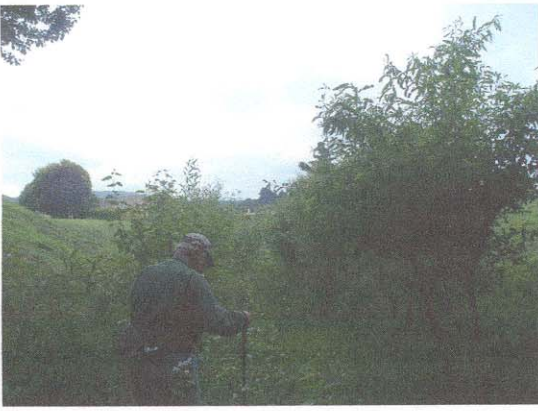
Picture 1

There are a few trees that have been planted in one single file row, however, many of these were cut down (See Pictures 1 and 3). Many of the new recruits are cut down when the banks and bed are mowed. All of the cuttings of these are left in the creek (See Pictures 1, 2, 3)

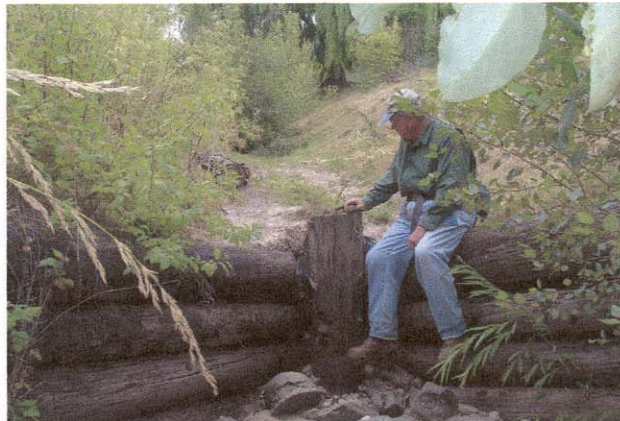
Picture 4

There is headcutting at the confluence with the Carmel River and seemed to have been where a wooden wall about 2.5 ft. high was constructed (See Picture 4).

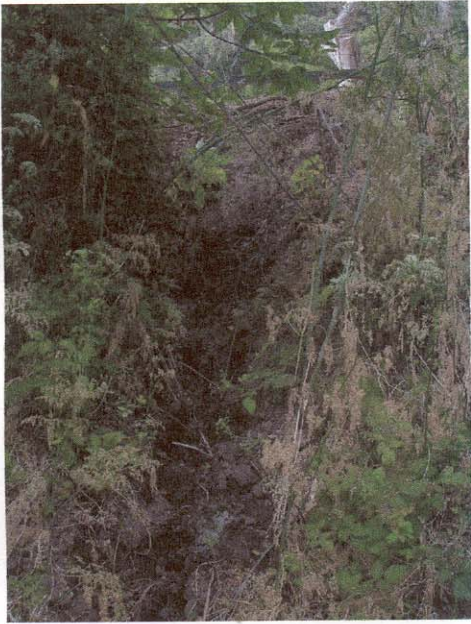
Picture 5

There is a lot of sediment throughout the reach and there were three gullies leading from the road, golf cart trail and the golf course (See Picture 5).
