Standard Checklist

Name of Riparian-Wetland Area: Robinson Canyon Creek

Date: June 25, 2004 Segment/Reach ID: Reach 10 PFC 201

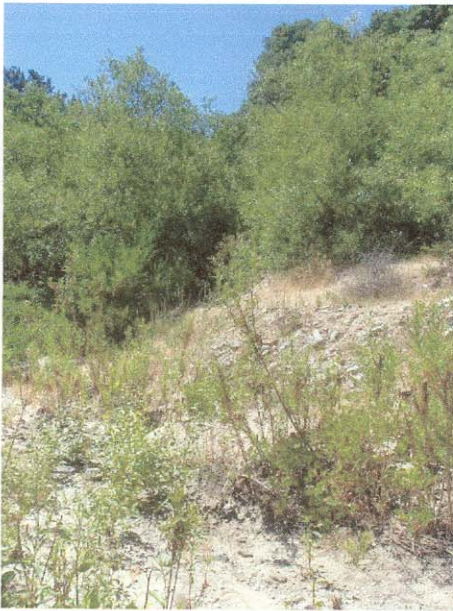
Picture 1

There is an excess of sediment throughout the reach. The creek bed is covered in sand with a few large rocks, and a section of bedrock incising (See Pictures 1, 2, 5 and 6). There are very few cobbles seen in this reach. There are large piles of fines that only seem to be revegetating; the new willows are growing from the remnant root systems of willow trees that had been cut down a few years ago. The creek banks on this reach are terraced, and the northeastern bank resembles a berm with sizable channel running behind it (See Pictures 1 and 2).

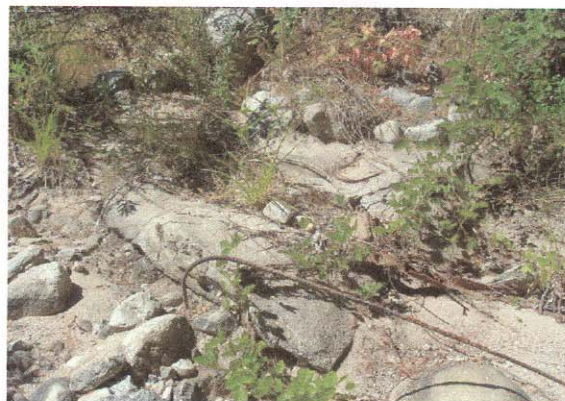
Picture 3

There were pieces of scrap metal, a loose telephone cable hanging from the pole above (See Pictures 3 and 4).

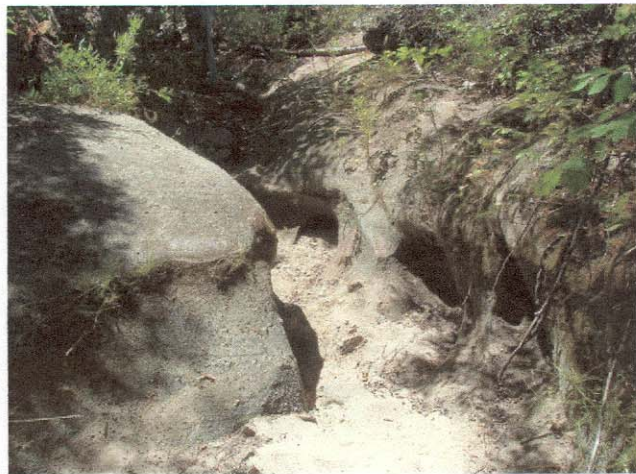
Picture 8

There are banks eroding with trees becoming undercut (See Pictures 8 and 9). Much of the bankfull behind houses in the area was built up and abutted with rocks after the 1998 flood.

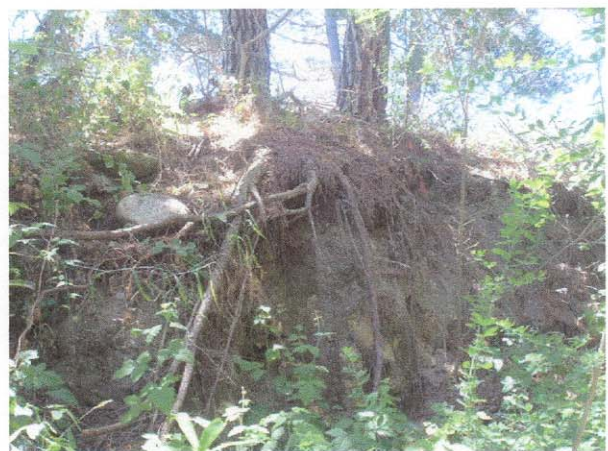
Picture 7

The vegetation is minimally diverse in its age-class and composition. The riparian wetland vegetation found was composed of willows, alders and buckeyes. Many of these had yellowing leaves and are brittle (See Picture 7). There are no grasses, sedges or bushes. There are a few older tree recruits present but there are no bush or sedge recruits. Many upland species were found directly on the creek bank, including monkey flower, genista and many upland grasses.
