Standard Checklist

Name of Riparian-Wetland Area: Hitchcock Creek

Date: May 24, 2004 Segment/Reach ID: Reach 3 PFC 303

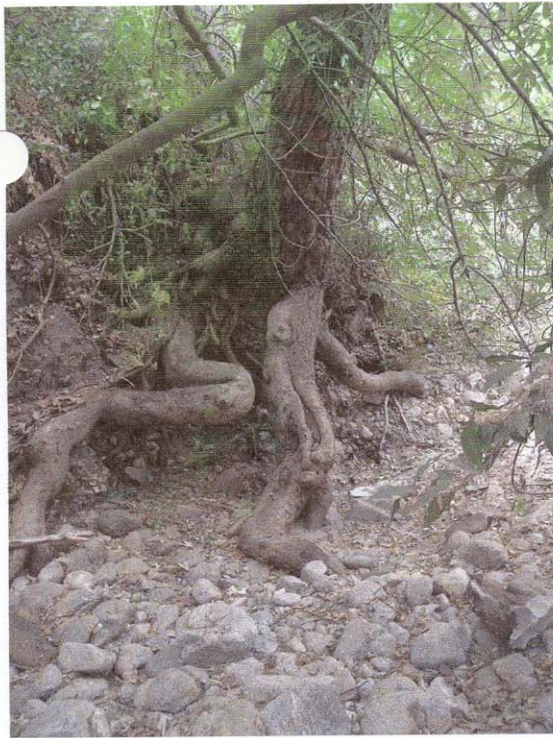
The banks are eroding and a few trees are severely undercut (See Picture 1).

#16 Both banks are eroding
