Standard Checklist

Name of Riparian-Wetland Area: Hitchcock Creek

Date: June 7, 2004 Segment/Reach ID: Reach 14 PFC 314

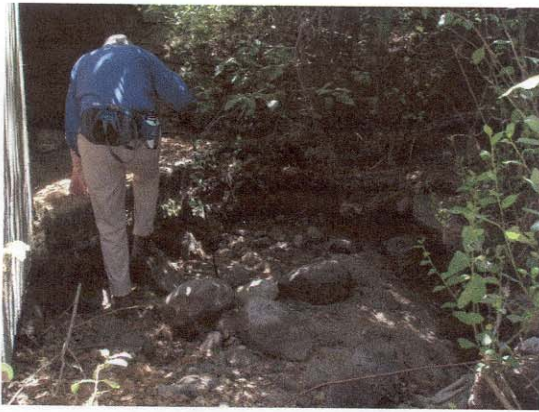
Picture 1

Bridge 519 is severely eroded on both sides and is currently a sizable fish migration impairment. There is a large sediment deposit just downstream from the bridge. The buttressed wall downstream from the bridge and the base of the bridge are so severely eroded that there is at least an 8" gap under them exposing the re-bar of the concrete. The bridge base is 2.5 ft. higher than the creek bed and is opposite a severely undercut tree. the soil behind the bridge wall is also being eroded and undercut as is the upstream side of the bridge (See Pictures 1 and 2). The sandbagged concrete that had been used to help shore up both sides of the bridge is also extremely eroded.

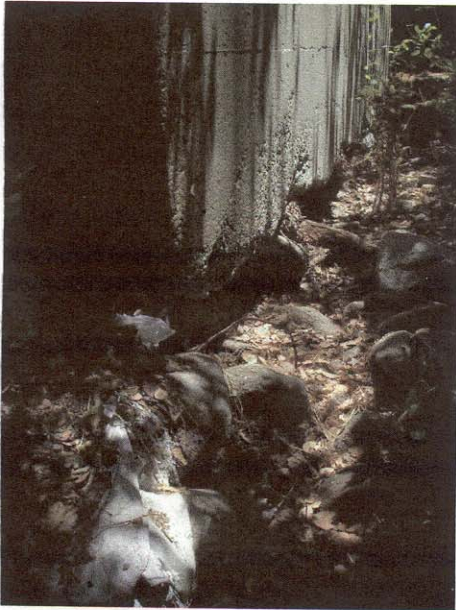
Picture 2

#15 Due to the bridge the stream makes a sharp angle on the downstream side that directs the creeks flow into the undercutting tree.

#16 The system is not vertically stable where the bridge is severely undercut.
