Standard Checklist

Name of Riparian-Wetland Area: Hitchcock Creek

Date: June 14, 2004 Segment/Reach ID: Reach 18 PFC 318

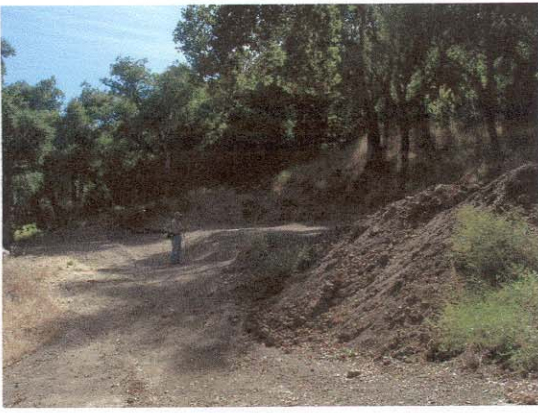
Picture 1

The upland to the west has enormous amounts of soft dirt in piles along the cleared hill and road side with nothing to stabilize them in the event of a low or high flow (See Picture 1). The sediment flow seems to enter the creek at two places; there are a series of haystacks on the west side of the creek on the upstream side of the bridge and the downstream west side of the bridge has a concreted bank where the large sediment piles sit directly below (See Pictures 2, 3 and 4).

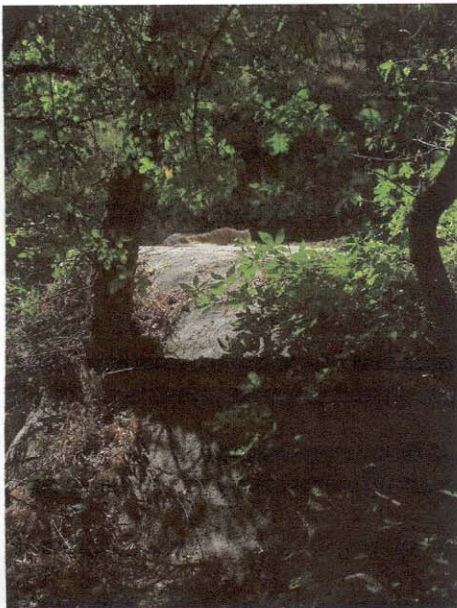
Picture 2

There is a large log jam that is causing the enormous amount of sediment to be dropped near the downstream base of the bridge (See Pictures 2 and 3).

#12 There is plenty of LWD, some of which needs to be removed as it is greatly contributing to the enormous sediment drop.

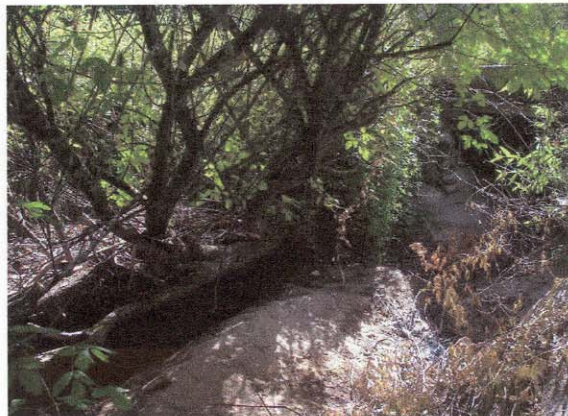
Picture 4

A smaller contributor to the degradation is a bridge with a concreted base and bank sides. Although it is not undercut, the base of the tree directly downstream is severely undercut, contributing more sediment to the system (See Picture 4).

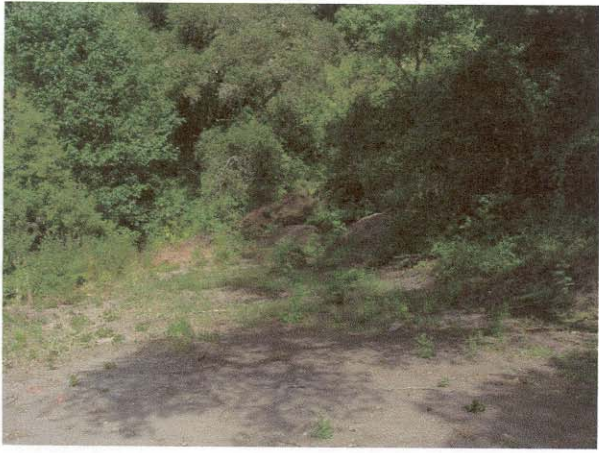
Picture 5

On the upland east side of the bridge is another area devoid of vegetation where dumping of excess dirt and rocks has occurred (See Picture 5) .
