Standard Checklist

Name of Riparian-Wetland Area: Cachagua Creek

Date: July 12, 2004 Segment/Reach ID: 7 PFC 409

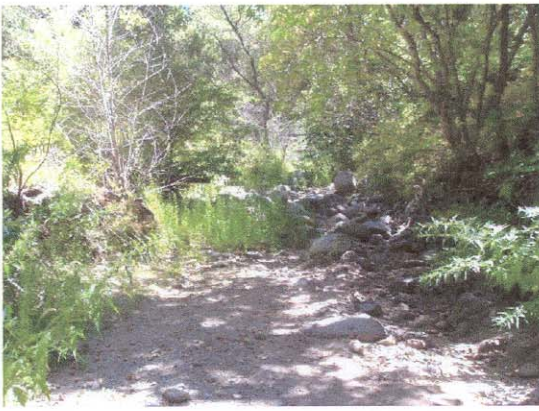
Picture 1

Dead alders were found in the reach (see picture 1).

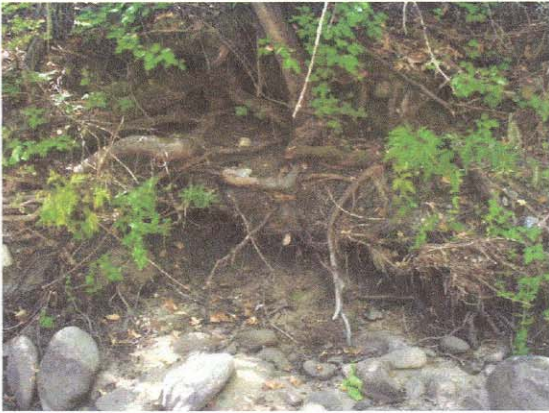
Picture 2

There are a few areas where undercutting and bank erosion have occurred on the road side of the creek (see pictures 2,4).

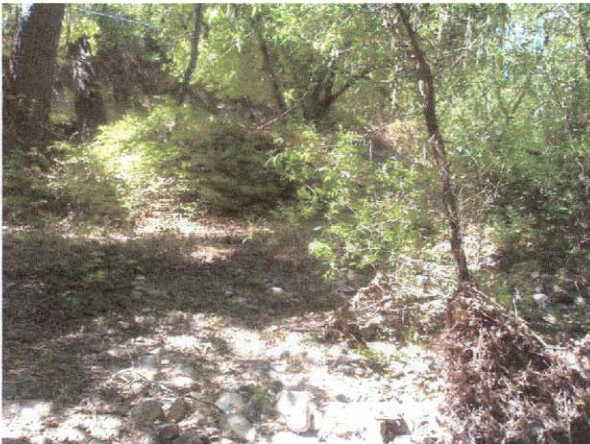
Picture 3

Plenty of large woody debris found in the reach (see picture 3).
