## Standard Checklist

Name of Riparian-Wetland Area: Cachagua Creek

Segment/Reach ID: Reach 6

PFC 410

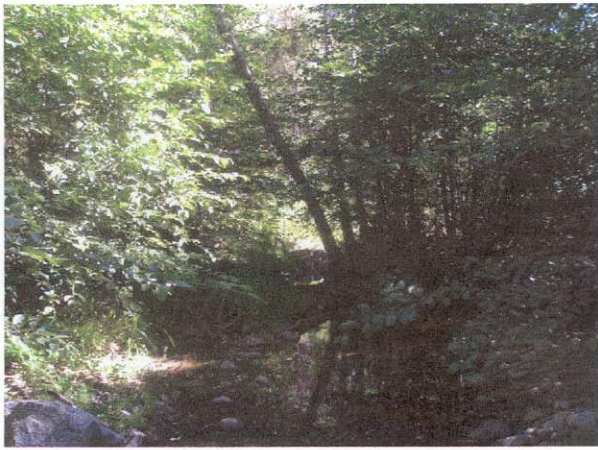
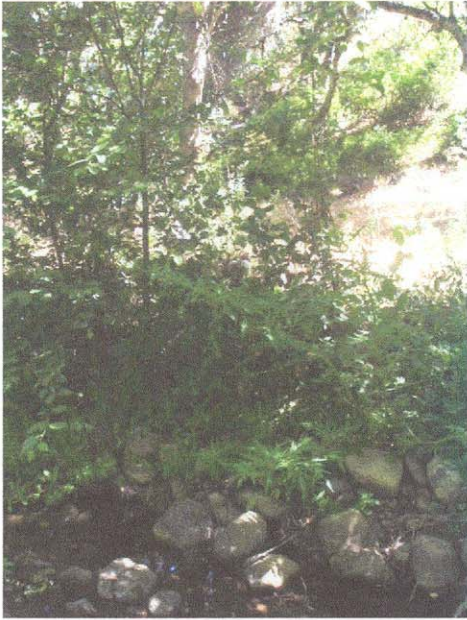
There is an efficient channelization system throughout most of the reach with abundant riparian wetland vegetation and large woody debris (see pictures 1,2).

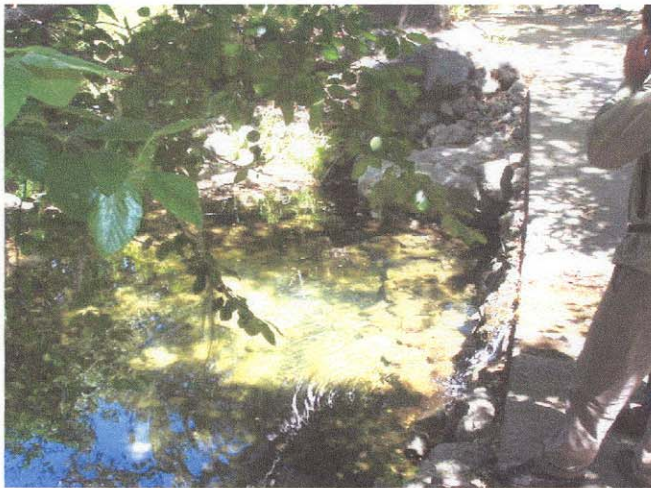
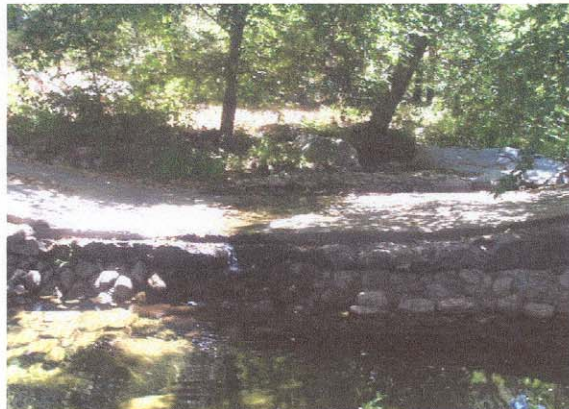
A concrete ford across the creek at residence 20775 forms a large pool below it accumulating considerable sediment. This pool contained an estimate of 50 YOY and at least one large yearling steelhead.

Residents of 20775 claim that water runs across the ford all year long most years, however when this study was executed in mid July 2004, there was barely an inch of water flowing over the ford. It is of note that in the later summer months, particularly in drought years, this ford probably forms a significant impediment to fish migration (see pictures 3,4).
