Standard Checklist

Name of Riparian-Wetland Area: Cachagua Creek

Segment/Reach ID: Reach 1

PFC 415

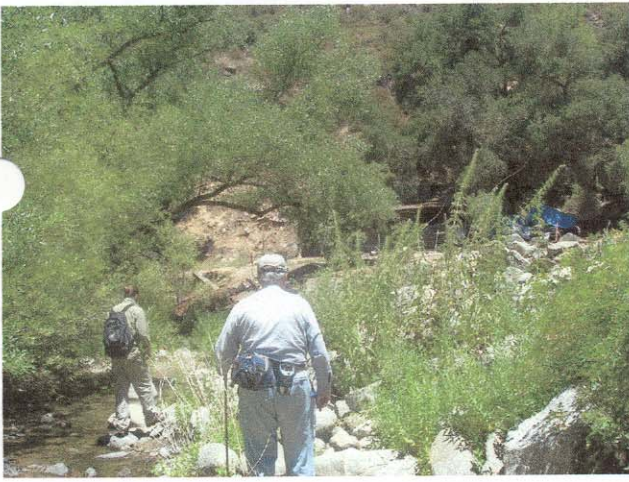
Picture 1

There are willows, oaks, alders, buckeyes, big-leaf maples, laurels and sycamores present (See Picture 1). There are many willow recruits present. However, there are also many upland species in the downstream part of the reach, including a profusion of alfalfa for at least 100 ft. (See Picture 4).

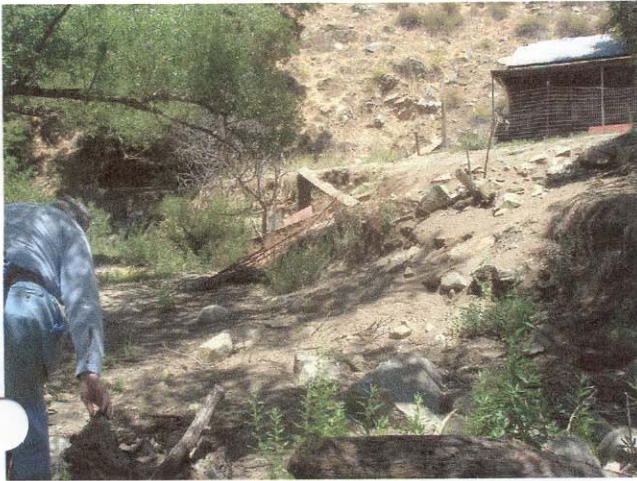
Picture 2

The driveway over the misshapen culvert leads to a house with no landscaping at all. This bare plain, is connected to the creek by extremely unstable banks and another smaller and lower unstable bare floodplain (See Picture 2). Further downstream is another residence void of landscaping, with no trees or bushes of any kind to stabilize the surrounding dirt.

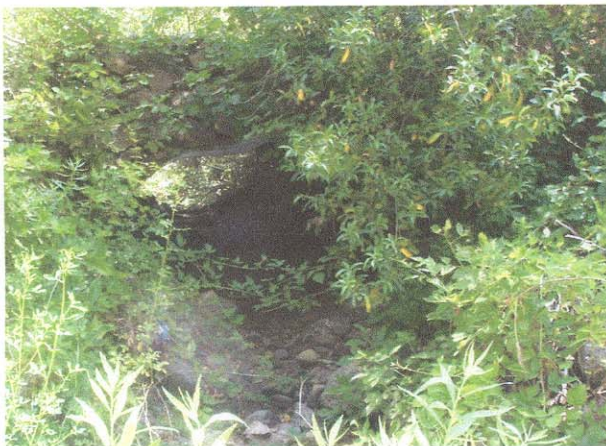
Picture 3

This reach begins at bridge 532 at the road crossing of Tassajara and Cachagua. Shortly downstream is a large misshapen culvert where Conejo Creek joins Cachagua Creek (See Picture 3).

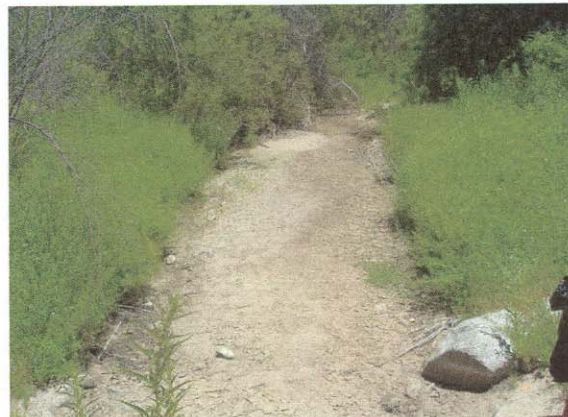
Picture 4

There is an excess of sediment throughout this reach (See Picture 4).

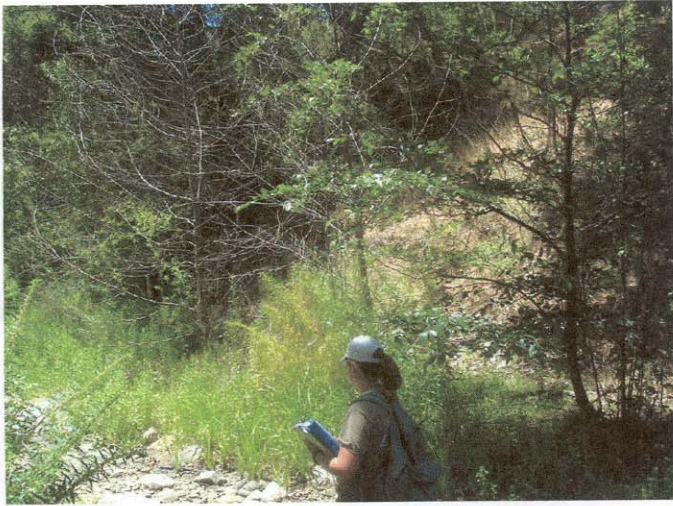
Picture 5

There were several dead alders at various sites throughout this reach (See Picture 5).
