Standard Checklist

Name of Riparian-Wetland Area: Finch Creek

Date: August 9, 2004 Segment/Reach ID: Reach 14 PFC 701

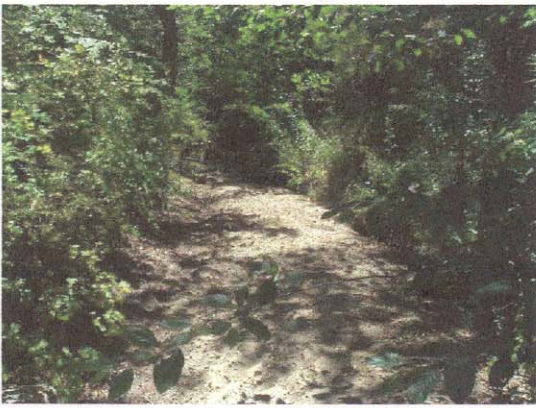
Picture 1

There are three large sediment deposits in this reach (See Picture 1).

#5 There were three sediment deposits in this reach, however the low gradient of this reach accounts for the amount of sediment that has built up here. Overall, this sediment deposition is not enough to cause concern for the wellbeing and stability of this habitat.

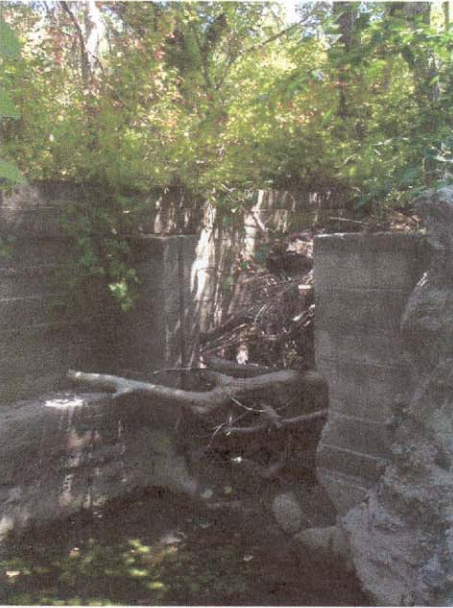
Picture 2

There is one concrete summer dam that is clogged by a potentially hazardous logjam (See Picture 2).

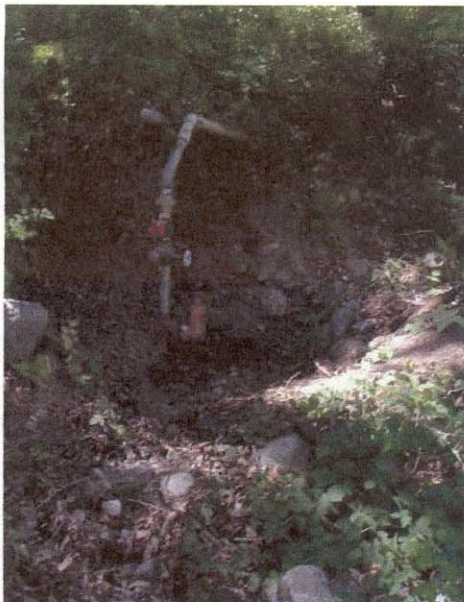
Picture 3

There is one well by two private footbridges (See Picture 3).

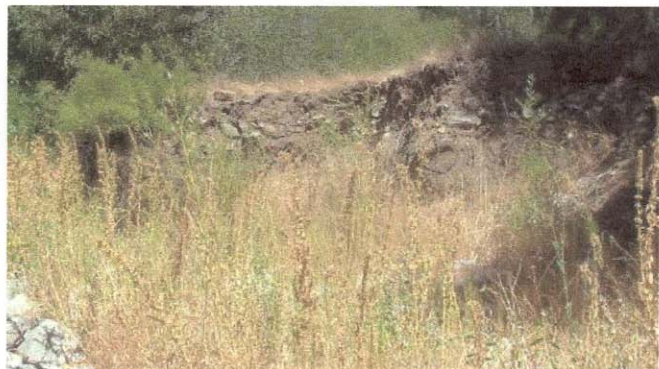
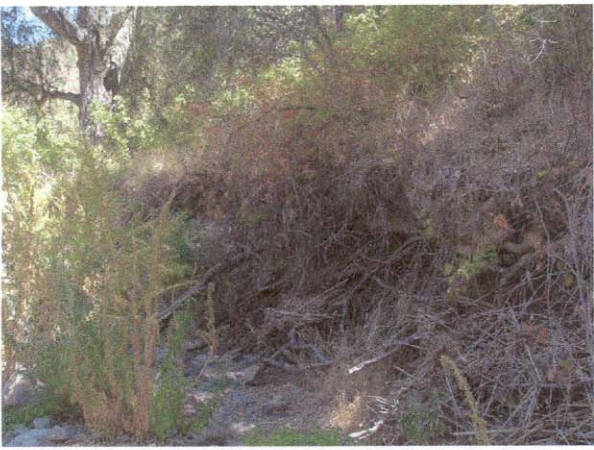
The end of the reach had several banks that were unstable and eroding (See Pictures 4 and 5).

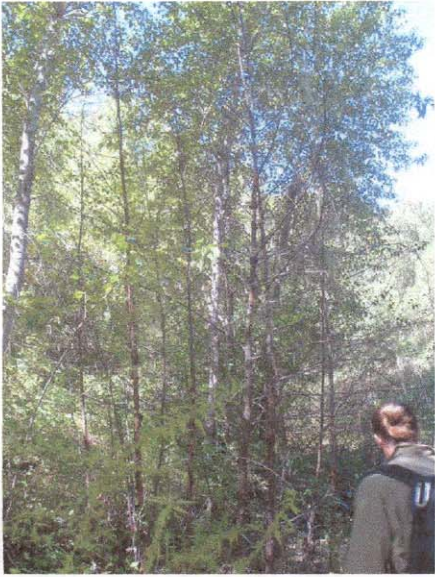
Picture 6

A few dead alders were seen in this reach, however, the remainder of the vegetation in this reach was ample and diverse (See Picture 6).

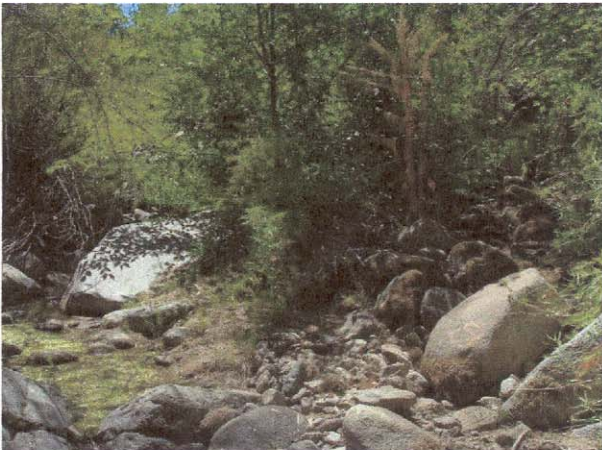
Picture 7

This reach ends at the confluence of Finch Creek and James Creek at GPS: N36, 23.363, W121, 35.658. (See Picture 7).
