Standard Checklist

Name of Riparian-Wetland Area: Finch Creek

Date: August 9, 2004 Segment/Reach ID: Reach 12 PFC 703

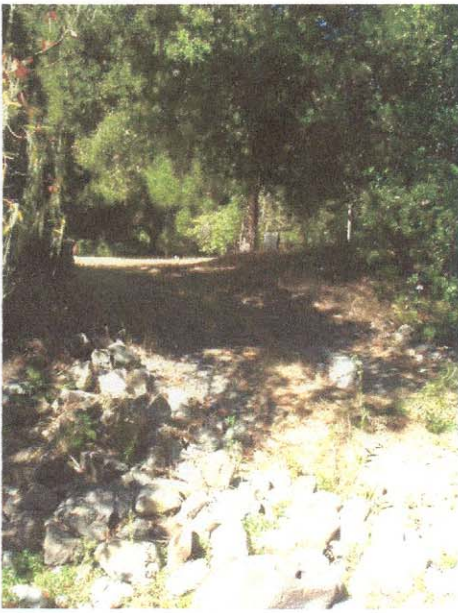
Picture 1

There is one dirt ford near a cabin (See Picture 1).

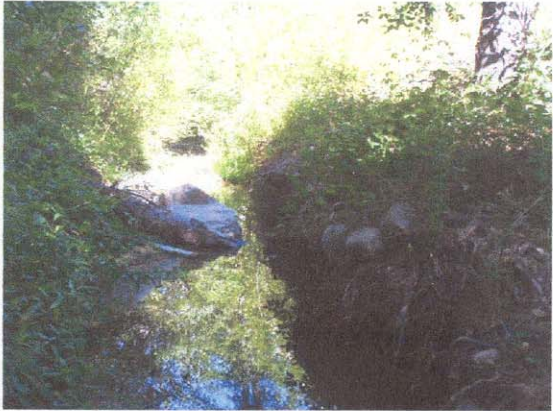
Picture 2

There are two undercut banks (See Picture 2).
