Standard Checklist

Name of Riparian-Wetland Area: Finch Creek

Date: August 2, 2004 Segment/Reach ID: Reach 5 PFC 710

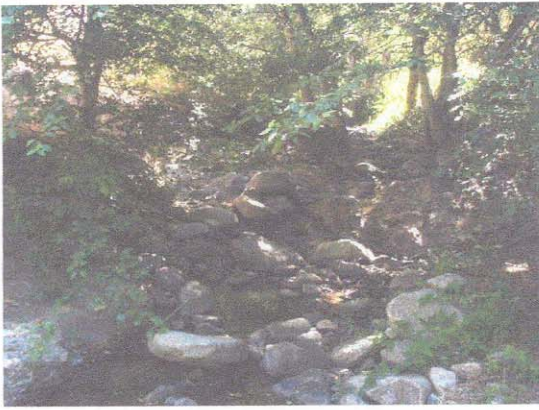
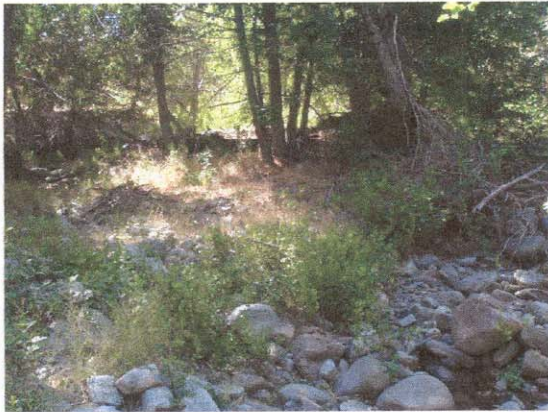
This area was very lush, with numerous channel systems (See picture 1,2).

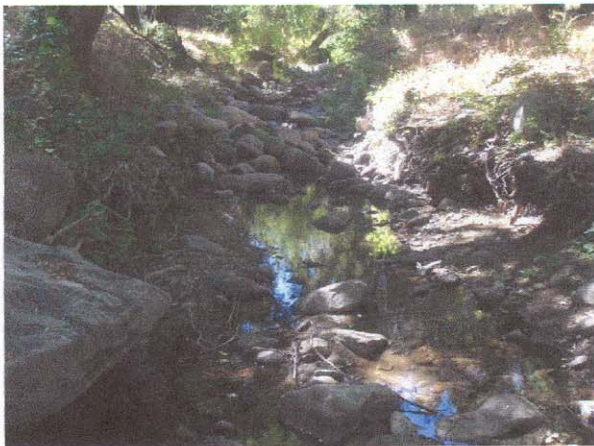
Picture 3

The roadside bank is eroding in a few insignificant, disparate instances. There is infrequent undercutting as well (See picture 3).

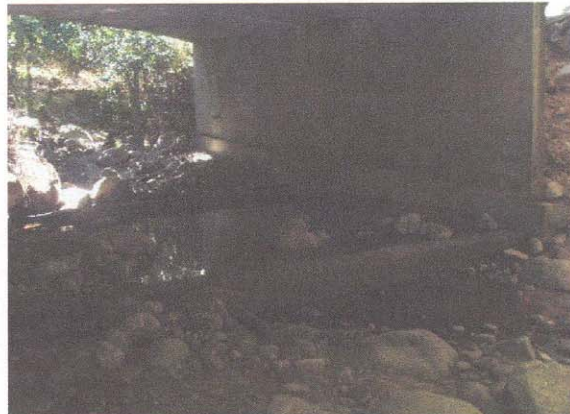
Picture 4

County bridge 543 has two concrete barriers in its foundation that span the width of the creek forming two large pools that could potentially be fish barriers (See picture 4).
