Standard Checklist

Name of Riparian-Wetland Area: Finch Creek

Date: August 2, 2004

Segment/Reach ID: Reach 4

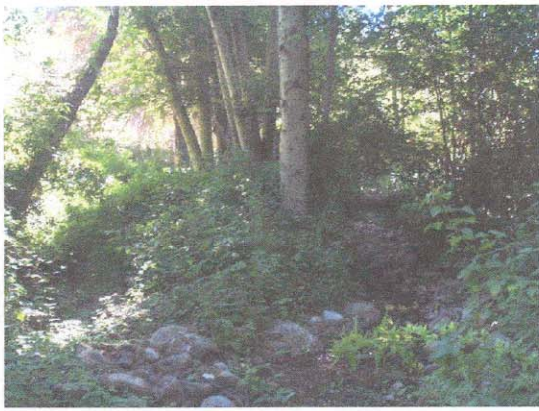
Picture 1

The vegetation throughout this reach was very lush, replete with dense willows and a very tall alder canopy (See picture 1).

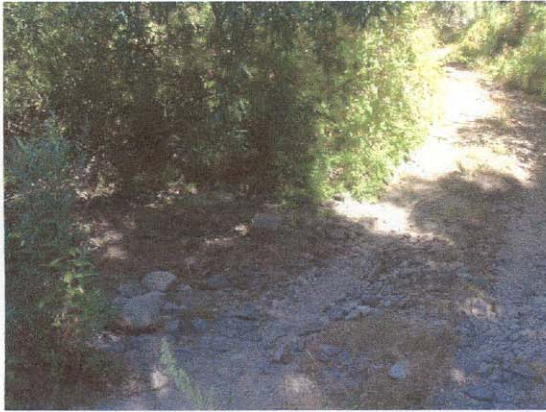
Picture 2

There is a dirt ford through the creek whose impact is imperceptible at this time (See picture 2).
