Standard Checklist

Name of Riparian-Wetland Area: San Jose Creek

Date: August 25, 2004 Segment/Reach ID: Reach 2 PFC 951

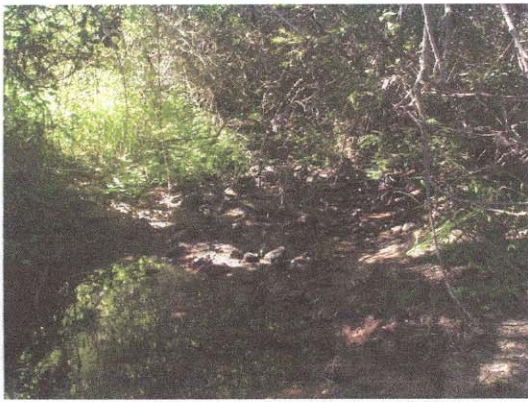
Picture 1

There is an overabundance of riparian growth, however there is no flow observed. There are a diversity of riparian trees including willows, cottonwoods and sycamores. (See Pictures 1 and 2).

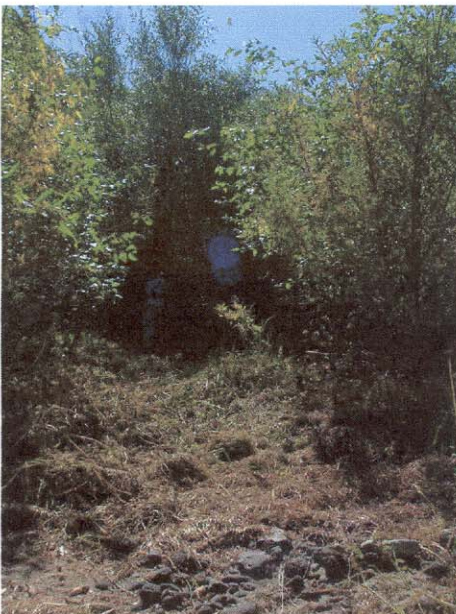
Picture 3

The creek is further from the eroding canyon walls than in reach 1 however, there is excess sediment in this reach. The excess sediment has allowed grasses to grow the span of the creek bed in some areas. (See Picture 3)

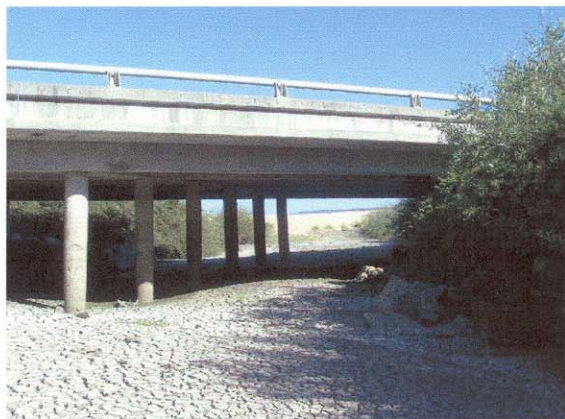
Picture 4

The mud under the bridge has dried up completely. (See Picture 4)
