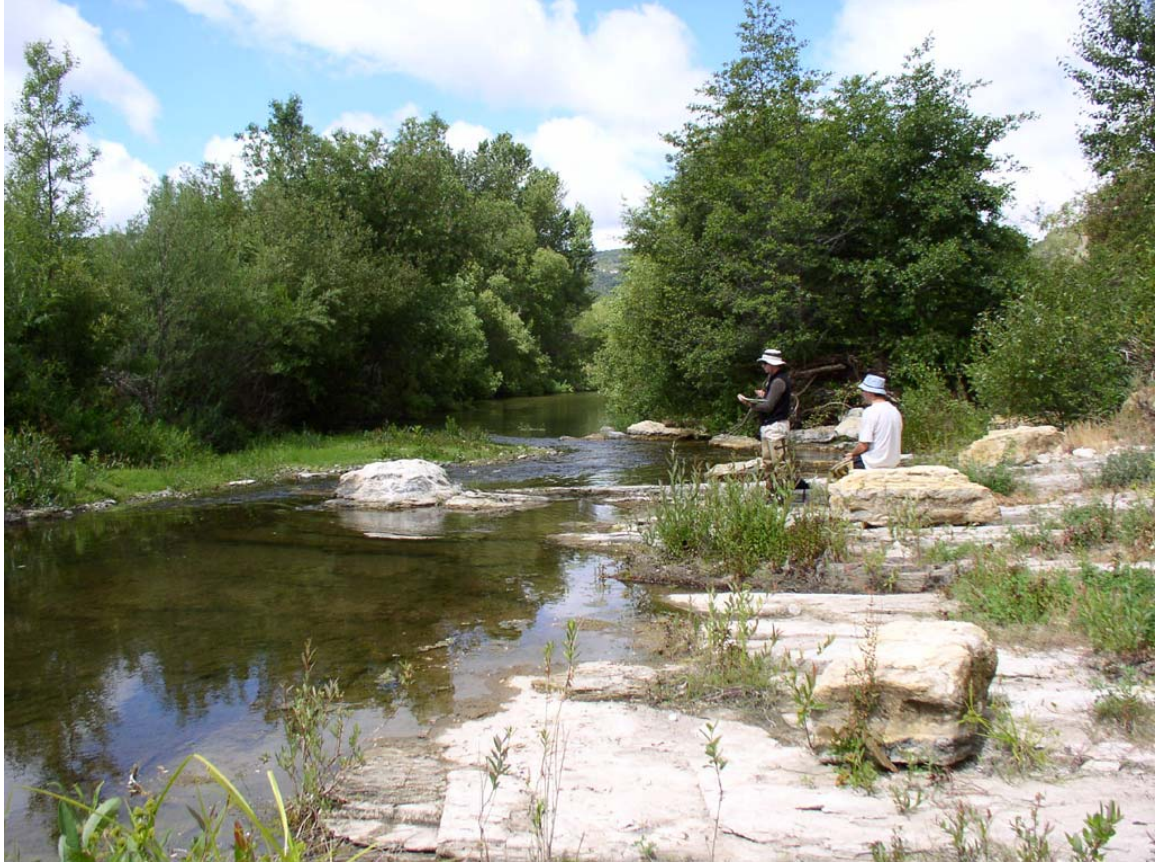
Primary riparian vegetation includes: black cottonwood, red and arroyo willow, white alder, and western sycamore. This reach is constrained on the south bank because of Carmel Valley Golf Course. In addition, Cal-Am's Scarlett well may dewater this area in a dry year.
