Standard Checklist

Name of Riparian - Wetland Area: Carmel River Watershed - Bruce Creek Area

Date: 1/28/04 Segment/Reach ID: 35-Carmel River just above Bruce Creek

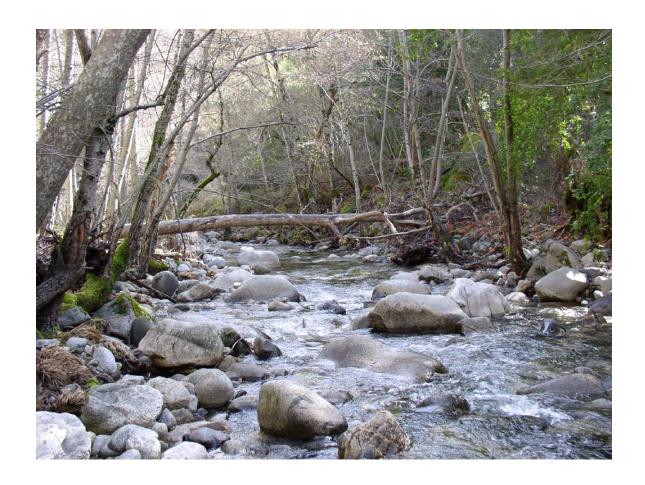
Large boulders and cobble exist to dissipate energy. Riparian species include white alder, Santa Barbara sedge, and western sycamore.
Summary Determination
Functional Rating:
Proper Functioning ConditionX Functional – At Risk Nonfunctional Unknown
Trend for Functional – At Risk:
Upward Downward Not Apparent
Are factors contributing to unacceptable conditions outside the control of the manager?
Yes No _ <u>X</u>
If yes, what are those factors?
Flow regulations Mining activities Upstream channel conditions Channelization Road encroachment Oil field water discharge Other (specify)
