Standard Checklist

Name of Riparian – Wetland Area: Rana Creek approximately one mile upstream of the confluence with Tularcitos Creek

Date: 10/05/03 Segment/Reach ID: 851

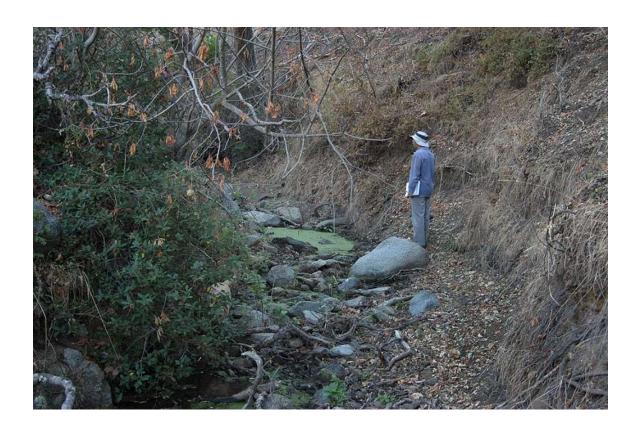
On October 5, 2003 there was standing water in this portion of the creek. With water
present this late in the season and no recruiting riparian vegetation this reach was rated
nonfunctional. It appears that pigs and cattle have frequent access to this area and are
preventing natural recruitment.
