Standard Checklist

Name of Riparian – Wetland Area: Rana Creek approximately 1 1/4 mile upstream of the confluence with Tularcitos Creek

Date: 10/05/03 Segment/Reach ID: 852

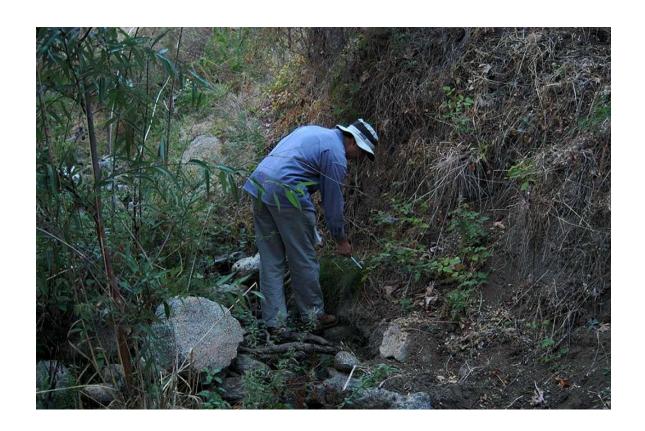
Riparian vegetation in this reach consisted of willows, sycamores, and Baltic rush.					
Summary Determination					
Functional Rating:					
Proper Functioning ConditionX Functional – At Risk					
Nonfunctional Unknown					
Trend for Functional – At Risk:					
Upward Downward					
Not Apparent					
Are factors contributing to unacceptable conditions outside the control of the manager?					
Yes No					
If yes, what are those factors?					
Flow regulations Mining activities Upstream channel conditions Channelization Road encroachment Oil field water discharge Augmented flows Other (specify)
